# **The PEPCON Disaster – Causative Factors and Potential Preventive and Mitigative Measures**

**Fourth International Seminar "Fire and Explosion Hazards",  
Londonderry, Northern Ireland, UK, September 8-12, 2003**

Lawrence  
Livermore  
National  
Laboratory

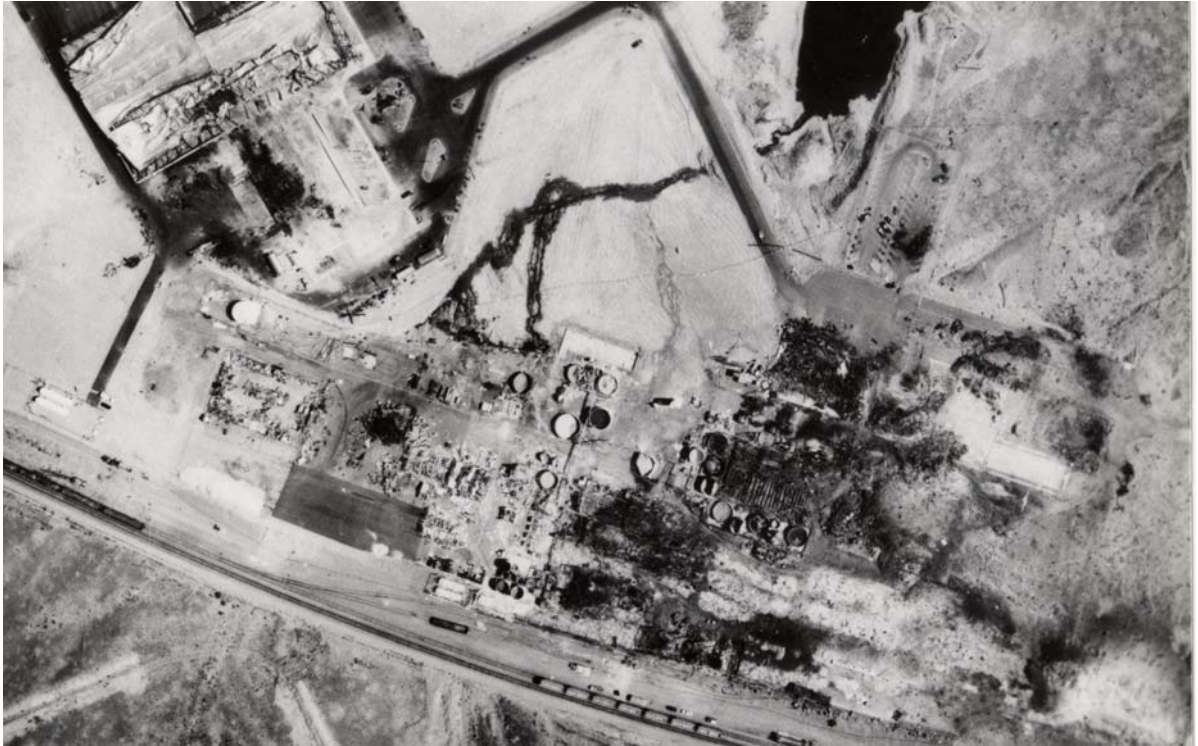
Pepcon was obviously aware of the fire risk of AP and production engineers were probably cognizant of the potential for explosion of bulk quantities of AP from past experience and transportation regulations. [5]. Moreover, experience of ignitions of AP sensitized organics at the Pepcon plant gave fair warning that they were working dangerously close to the safety limits of some process procedures. Nevertheless they pioneered the use of Poly drums for convenience and for corrosion control knowing that the combination of organic materials with oxidizers was unwise. Indeed, simple comparison of the explosion energy of AP alone and AP in combination with the mass of polyethylene of a poly drum is astounding especially considering the ignition sensitivity enhancement provided by the combination. Thermodynamic evaluation of the internal energy and entropy of explosion for pure AP and AP in stoichiometric combination with polyethylene or asphalt show that the explosive strength, referenced to TNT is 0.5 and 1.5 times TNT respectively [6]. Clearly, the mass ratio for polyethylene drums and the AP content was oxidizer rich and the consequent energy release less than the stoichiometric ratio. This is consistent with independent analysis based on close-in structural deformation, which suggested a TNT air blast equivalence factor of 0.333, relative to the total inventory of AP on site [7]. The results of these explosions are shown in Fig. 2 and 3.

Figure 2. Aerial photograph of plant post the explosions and fire.

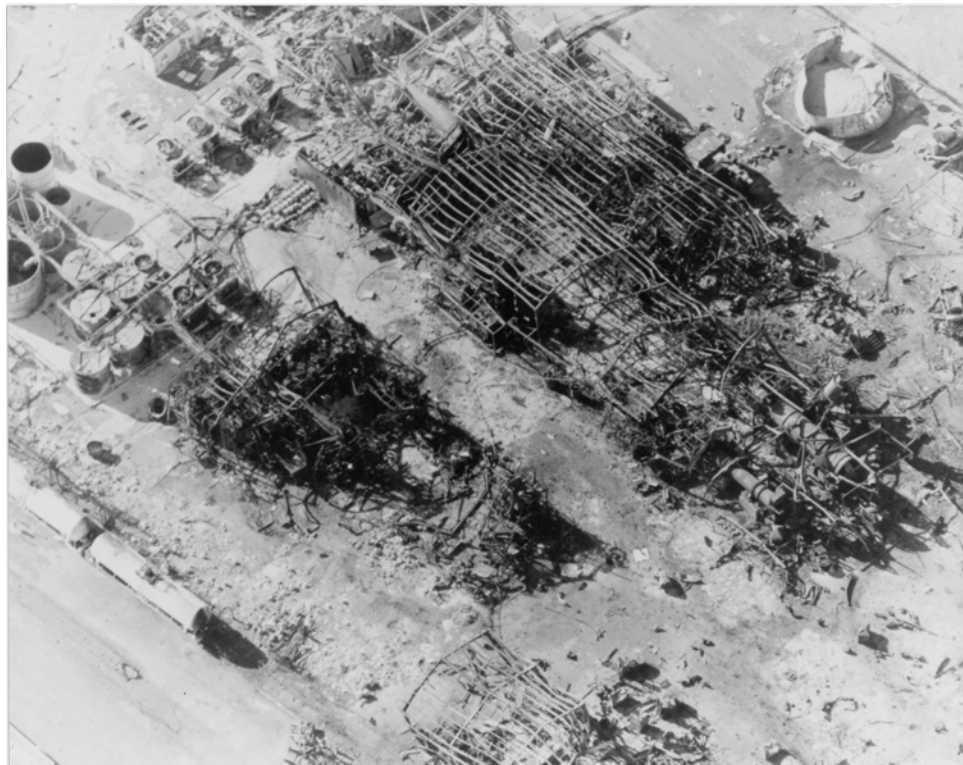
Figure 3. Aerial photograph of fire and explosion damage to process buildings around the batch dryer building.

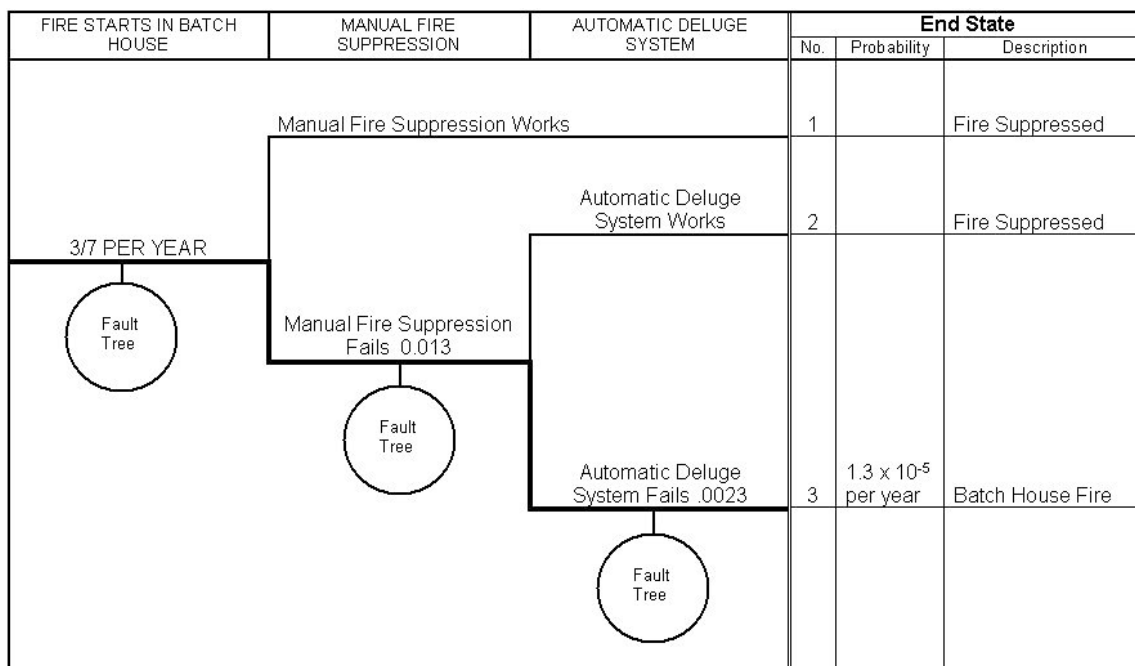
Figure 5. Event Tree Fire in Batch House Recommended System

suppression system was recommended. (The details of this system are described later.) The event tree with all the proposed preventive and mitigative features are shown in Fig. 5. Fault trees were constructed and probabilistically evaluated to estimate failure probabilities for the manual fire suppression system and automatic deluge system.

The top event probability (probability of failure for manual extinguishment) is calculated to be 0.013. The fault tree for the automatic deluge system is shown in Fig. 9. This fault tree shows the dominant causes of failure that include failure of the manual locked open manual valves, check valve failure and inadequate water supply in the fire tank. Failure of the pumps and signal actuation system did not dominate probabilistically due to redundancy. The top event probability for failure of automatic deluge system given a fire is calculated to be 0.0023. From Fig. 5, the total frequency of a batch house fire with recommended measures employed is:

The study recommended the inclusion of trained personnel that know how to manually extinguish a fire and conduct a fire watch in the event welding or hot work is occurring. The study recommended the use of hose system as the first line of defense in extinguishing a fire. In addition, the inclusion of an automatic fire

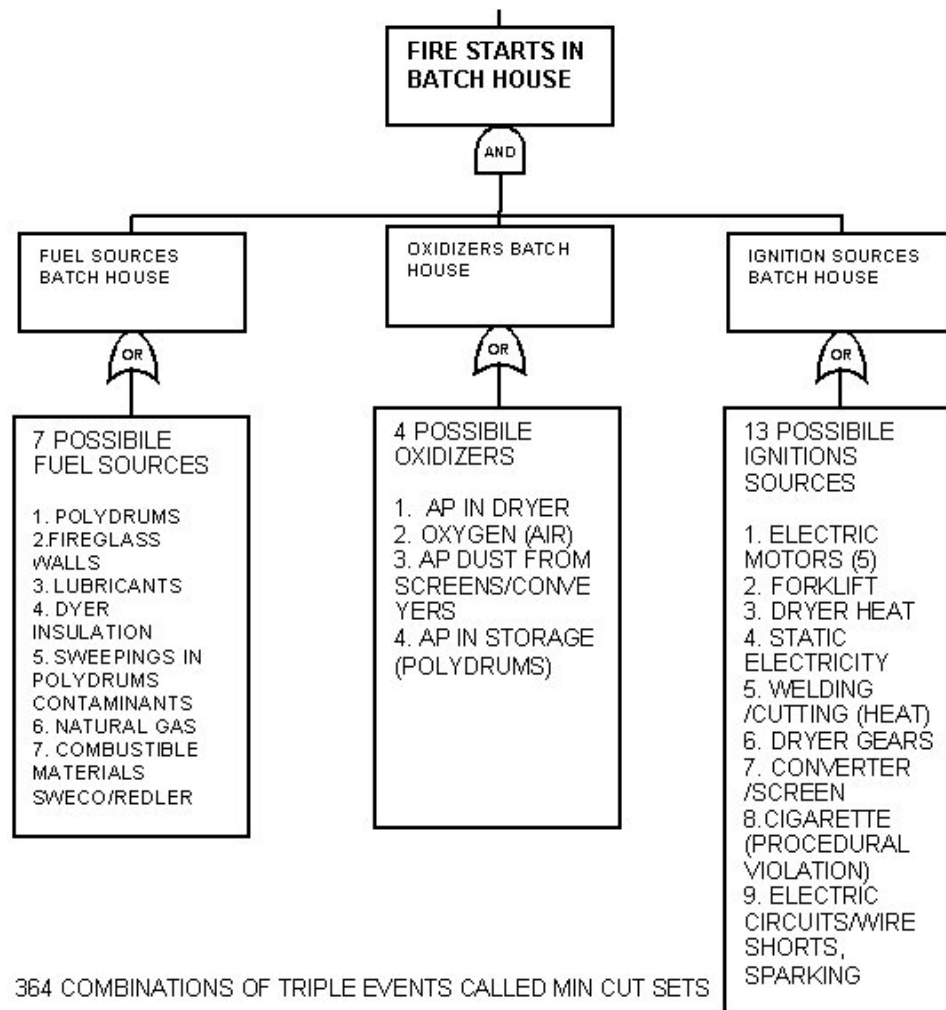
Figure 6. Fault Tree for Fuel/Oxidizer/Ignition Source

A fault tree is a deductive logic model. The fault tree starts with a defined top event, uses standard and or gates, is developed to the limit of resolution, called basic events. Basic Events include (1) equipment failure, (2) human error and (3) environmental conditions. A fault tree in Fig. 6 was used to generate the combinations of fuel sources, oxidizers and ignition sources. This fault tree is similar in scope to an interaction matrix. The study identified 7 possible fuel sources, 4 possible oxidizers and 13 possible ignition sources. There are a total of 364 combinations of triple events called min cut sets. The authors judge that the most likely ignition source for the batch house fire is incandescent particles from welding and/or flame cutting. An alternate ignition candidate is judged to be heat from the dryer that on previous occasions has ignited the dryer insulation made from cheesecloth.

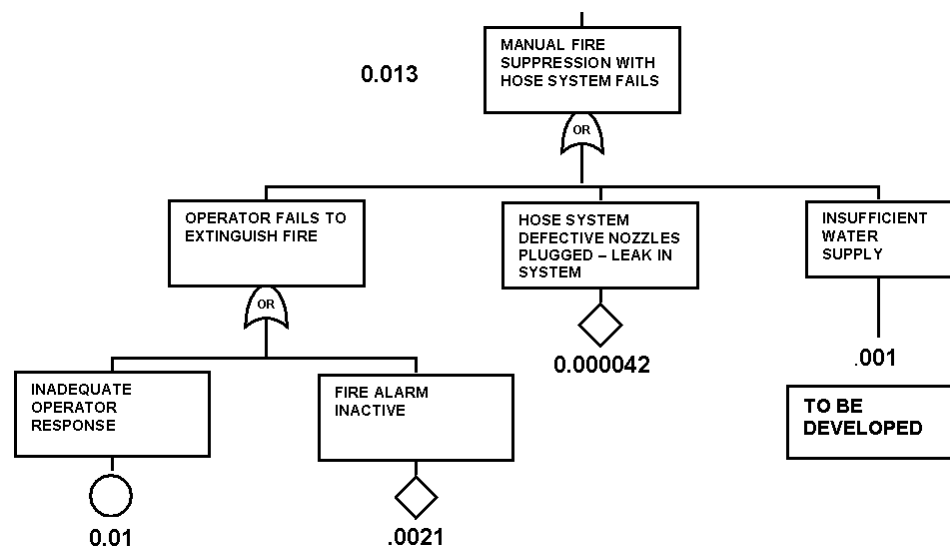
Figure 8 - Top Level Fault Tree For Manual Fire Suppression

The top level fault tree for manual extinguishment is shown in Fig. 8. The fifth step of the process was to quantify the fault trees and apply applicable probability data. The probability data that was used include Swain and Guttman, NUREG 1278 [14], Interim Reliability Evaluation Program, NUREG 2728 [15] and RADC, Non-electronic Reliability Notebook [16].
